Avoiding Failures: It's All About the Interfaces

Ned Patton
Patton Engineering and Consulting

Titan Carbon Fiber to Titanium Hull Joint

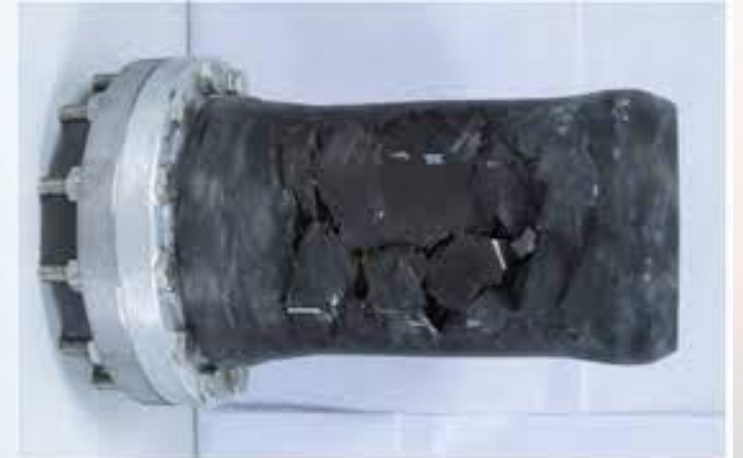
Composite/Metal Joint Most Critical

- Metals are isotropic, composites are not
 - External pressure causes strain mismatch between composite and metal
 - Strain mismatch – high interlaminar shear and tensile stress
- Results in:
 - Carbon fiber cylinder compressing more than metal attachment ring
 - High interlaminar tension and shear leading to bending in region of metal ring
- Composite delamination likely result

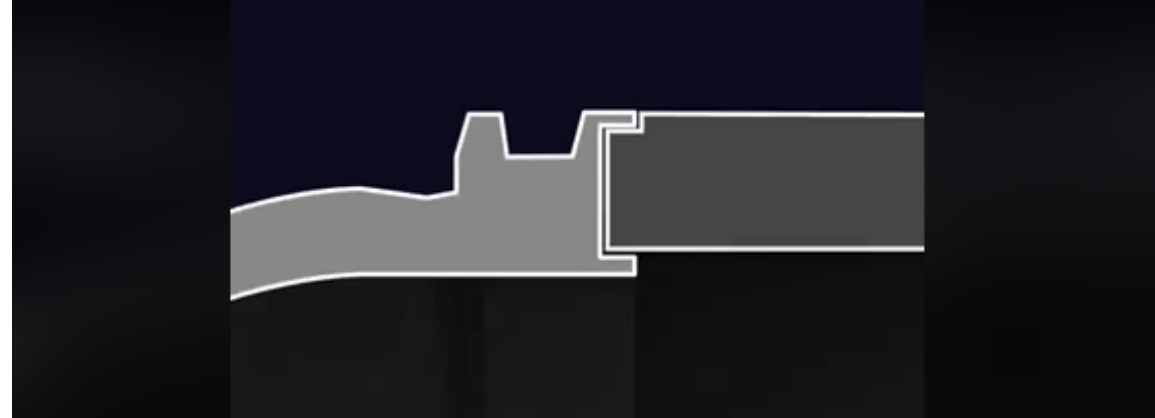
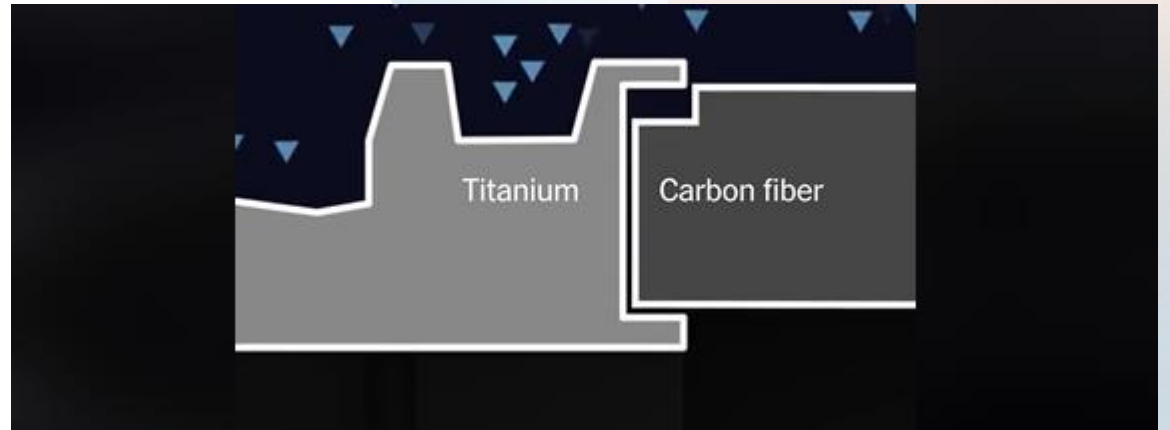
- Captured composite joint design
- Titanium stiffness ~17 MSI
- Carbon/Epoxy
 - Through thickness ~1-2 MSI
 - Hoop ~10-20 MSI
- Were material coupon tests performed?
- Was joint design tested to failure?
- Was cyclic damage assessment made?
- Structural health monitor?
